HIGH SCHOOL

Scope: Structural Assessment and Remediation Design for an Existing Indoor Swimming Pool Structure

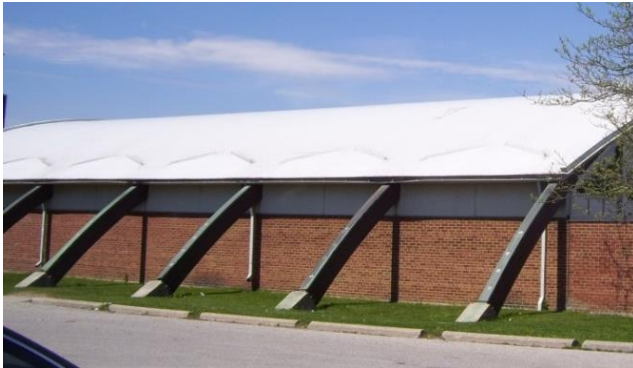
Original exterior elevation

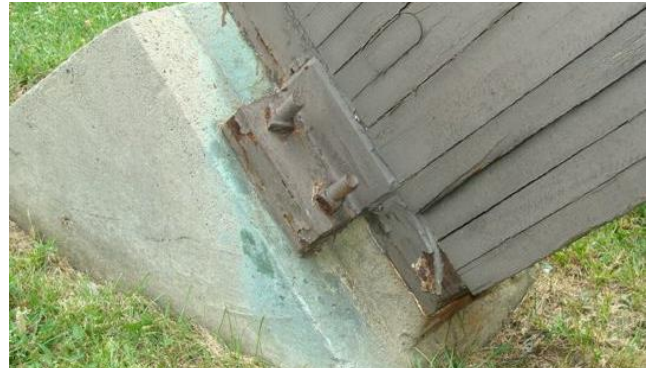
Deterioration of existing exterior glulam beam

Services Provided: An innovative repair solution for damaged glulam arches spanning 100 feet over a swimming pool. Heavy galvanized steel shoes were used to replace the deteriorated wood bearing ends and provided a contemporary feel to this 50 year old structure. The structural work also included customized shoring towers and tensioned cable stays to support the large roof area while arch supports were cut off and the steel shoes were installed. The work was carried out in a phased manner on alternate arches and alternating sides of the pool enclosure. This was a unique solution to a unique problem and was completed in a successful and cost appropriate manner.

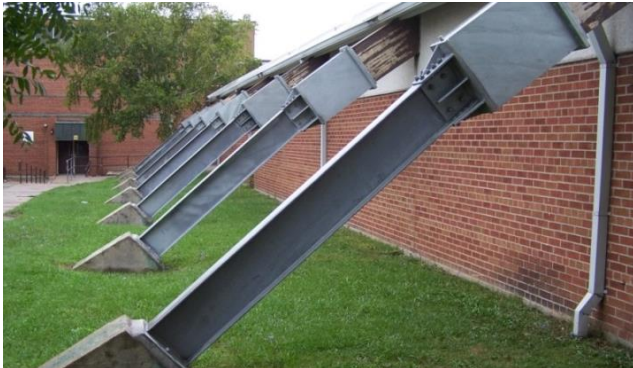
Final condition of remediated beam

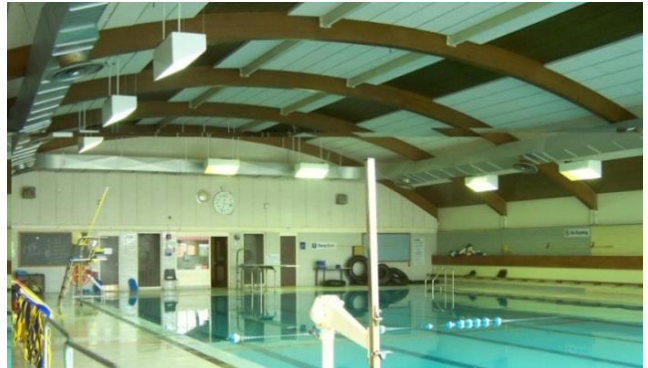
Final interior condition
