**MUNICIPAL BUILDING**

**Scope:**

Window Condition Assessment, Drawings, Details, Specifications, and Quality Observations for Window Replacement. Structural Design and Drafting for New Window Installation.

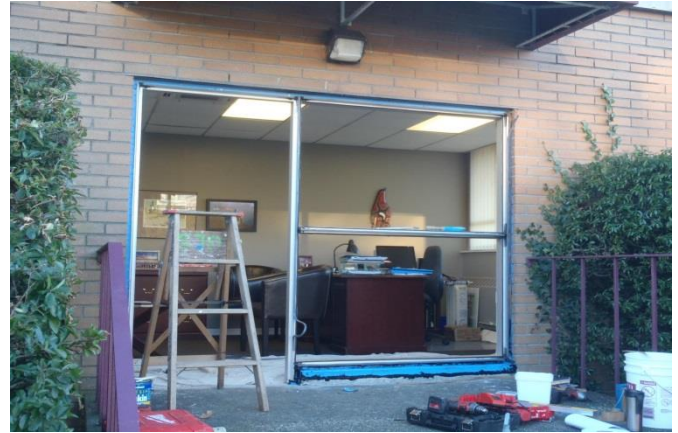
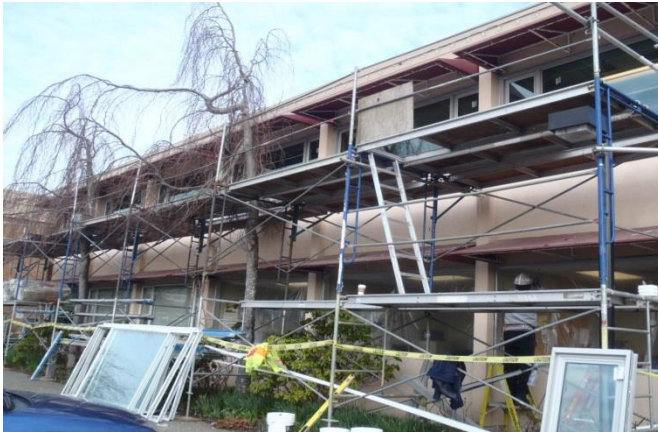
Window Replacement in Progress

Existing punch windows were replaced with new Starline 9000 Window System throughout the building with related flashing, sealant, waterproofing and tie-in works. Existing curtain wall system was replaced with new Kawneer 1602 Curtain wall system. A new window was added into an existing brick wall with associated structural work. Alas, a few sections of the new fenestrations were field tested based on ASTM E1105 with no water leakage reported.

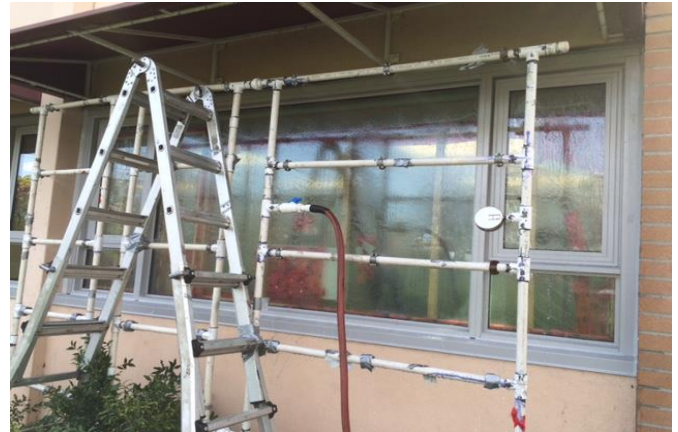
Field Testing of a New Window
