**MUNICIPAL BUILDING**

**Scope:**

Window Condition Assessment, Drawings, Details, Specifications, and Quality Observations for Window Replacement. Structural Design and Drafting for New Window Installation.

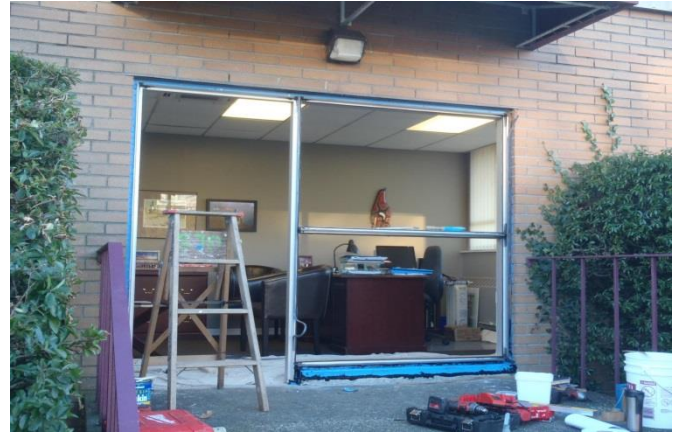
Front of the Building

Existing punch windows were replaced with new Starline 9000 Window System throughout the building with related flashing, sealant, waterproofing and tie-in works. Existing curtain wall system was replaced with new Kawneer 1602 Curtain wall system. A new window was added into an existing brick wall with associated structural work. Alas, a few sections of the new fenestrations were field tested based on ASTM E1105 with no water leakage reported.

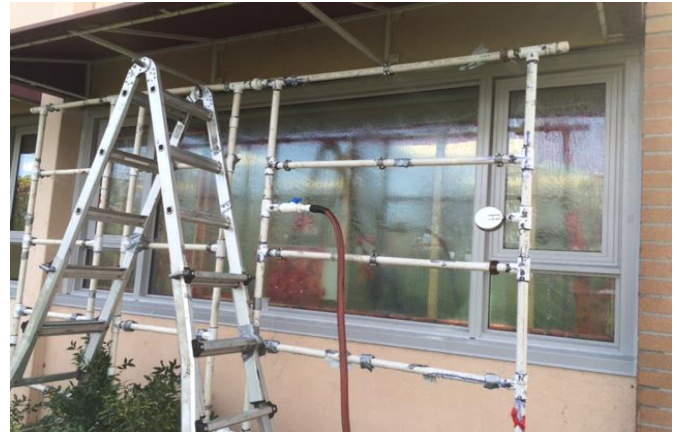
Field Testing of a New Window
