PROJECT PROFILE – *Building Envelope*

Project Name: Scott Central Public School - Sandford, Ontario

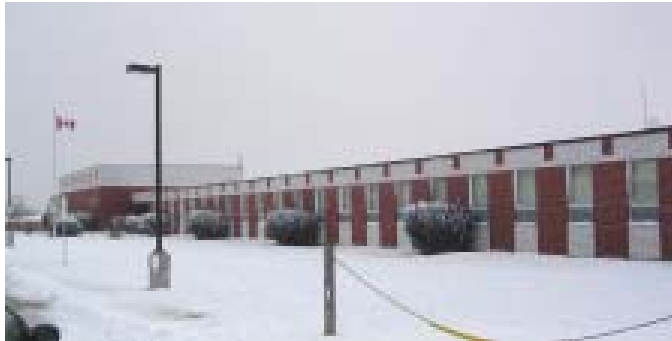
Before

Scott Central Public School, (circa 1960's), utilized an unreinforced composite load-bearing exterior masonry wall. The lack of air space and the use of glazed brick masonry contributed to exterior deterioration. In addition, a cast in place continuous concrete beam was above the windows and had begun to hinge outward causing issues in that area of the building.

The exterior brick masonry was replaced to correct the structural concerns of the exterior wall and to remove the observed deterioration. The new masonry allowed for structural steel strapping to be added, which provided a positive tension member and increased thermal performance of the wall system. These enhancements allowed for appropriate through wall flashings, and spray polyurethane foam insulation to be added. The new wall structure consisted of new brick masonry, insulation, sufficient air space and appropriate masonry ties. Colour and coursing was done to ensure the expansion matched the existing masonry.
